Service Bulletin

#10016583 Rev. A June 5, 2007

Service Alert: Potential for Water Contamination in Hub Lubricant Due to Flooding

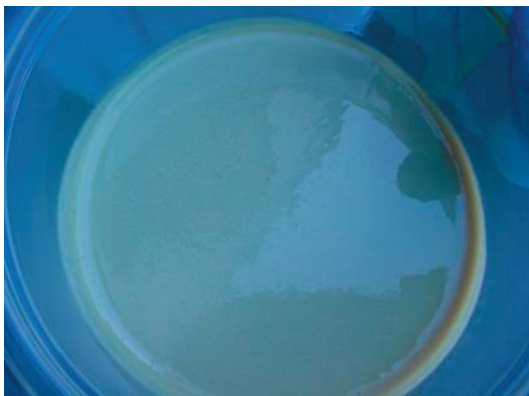
A visual inspection of the hub lubricant is advised. Oil, such as a 50 weight synthetic, with a small amount of water added will turn to become a milky white color (figure 1). Semi-fluid grease will also turn a milky color. However the color change will depend on the grease's base color. Figure 2 shows semi fluid grease after water contamination. Its base color was a red/pink color and after contamination the lubricant has turned a milky shade of pink.

Figure 1: 50 weight synthetic oil contaminated with a small amount of water turns milky white.

Contaminated lubricant should be removed from hub assembly and replaced with new lubricant. Hub cavity should be thoroughly cleaned to ensure removal of all contaminated lubricant.

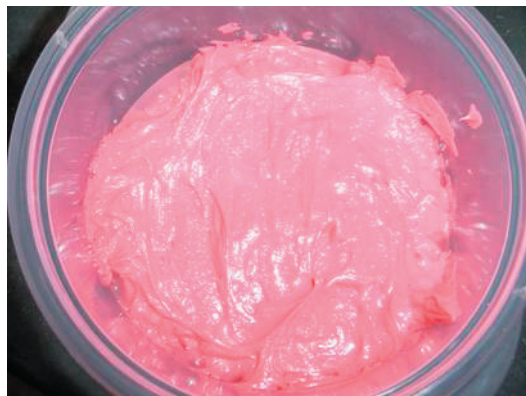
Figure 2: Red/pink semi-fluid grease contaminated with a small amount of water turns milky pink.
