Service Bulletin

#10012133 May, 2004

Removing Frozen Hubs From Spindle

All ConMet® hub assemblies

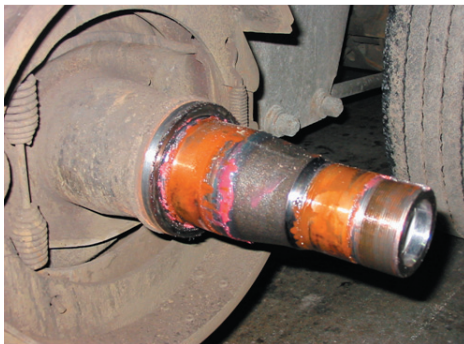
Figure 1

1. Minor wheel bearing failure
2. Fretting corrosion between the bearing cones and axle spindle (see figure 1 and figure 2)

Fretting Corrosion is corrosion that can occur on the load bearing contact surface between mating material, leaving a reddish-brown stain on the spindle or bearing cone.

In cases where fretting corrosion is found on the spindle bearing journals, it should be removed with a fine abrasive, such as emery cloth, prior to reinstalling the hub assembly. Consolidated Metco recommends that a thin coating of a grade 2 grease, preferably moly based be applied to the spindle bearing journals prior to installing the hub to prevent fretting corrosion from reoccurring.
