# Service Bulletin

#10009974 Rev. March 30, 2004

## Stamped ABS Ring Removal and Installation

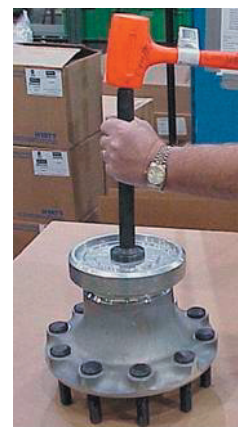
Figure 4

Place the ABS ring onto the hub. For steer axle hubs, make sure the inside diameter flange is up (Figure 3). Center the corresponding diameter of the tool onto the ABS ring. Drive the ring onto the hub with a hammer or mallet (Figure 4). Visually inspect the ring to insure that it is completely seated onto the hub.
